**SYSTEMS GROUP CHAIRMAN FACTUAL REPORT ADDENDUM FOR
BOEING/AIR FORCE CENTER WING TANK FUEL HEATING STUDY**

A. ACCIDENT: DCA96MA070

Airplane : Boeing 747- 131, N93119
Operated as Trans World Airlines (TWA) Flight 800

TITLE CENTER WING TANK FUEL HEATING STUDY
(VOLUME I OF IV)

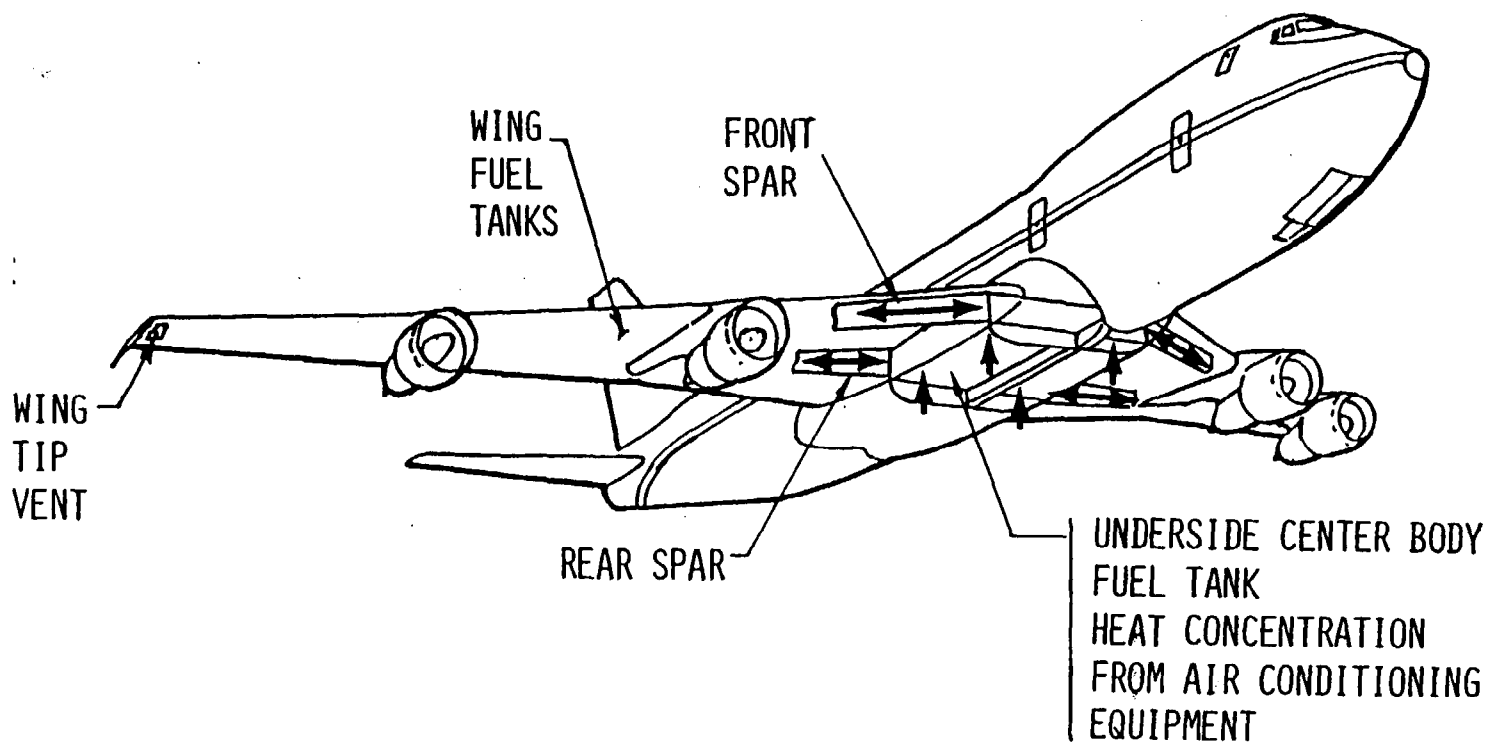
Figure 2.1 illustrates the general location of the center wing tank and addresses sources of heating for the fuel. The front spar and upper surface of the tank are exposed to the air conditioned aircraft cabin. The rear spar is exposed to the wheel well which is open to ambient air under the aircraft. The major head load appears to be due to the high temperature in the air conditioning equipment by acting over the base of the tank. The final heat transfer path considered is that between fuel tanks, both by conduction transfer along the spars and by convection currents at the intertank bulkheads. In the analysis to be subsequently discussed, the center wing tank (CWT) was warmer than the wing mains; thus the wing tanks served to provide a cooling path for the CWT. Note, however, the cooler the wing tank fuel, the more effective will be this mode of cooling.

FIGURE 2.1
E-4 FUEL TANK SURFACES AFFECTED BY HEAT

The center wing tank is bounded; across the front spar by the forward lobe, on the upper surface by the main deck floor support structure, across the rear spar by the wheel well, on the lower skin by the air conditioning equipment bay, and on the sides by the bulkhead between the center tank and the inboard wing mains.

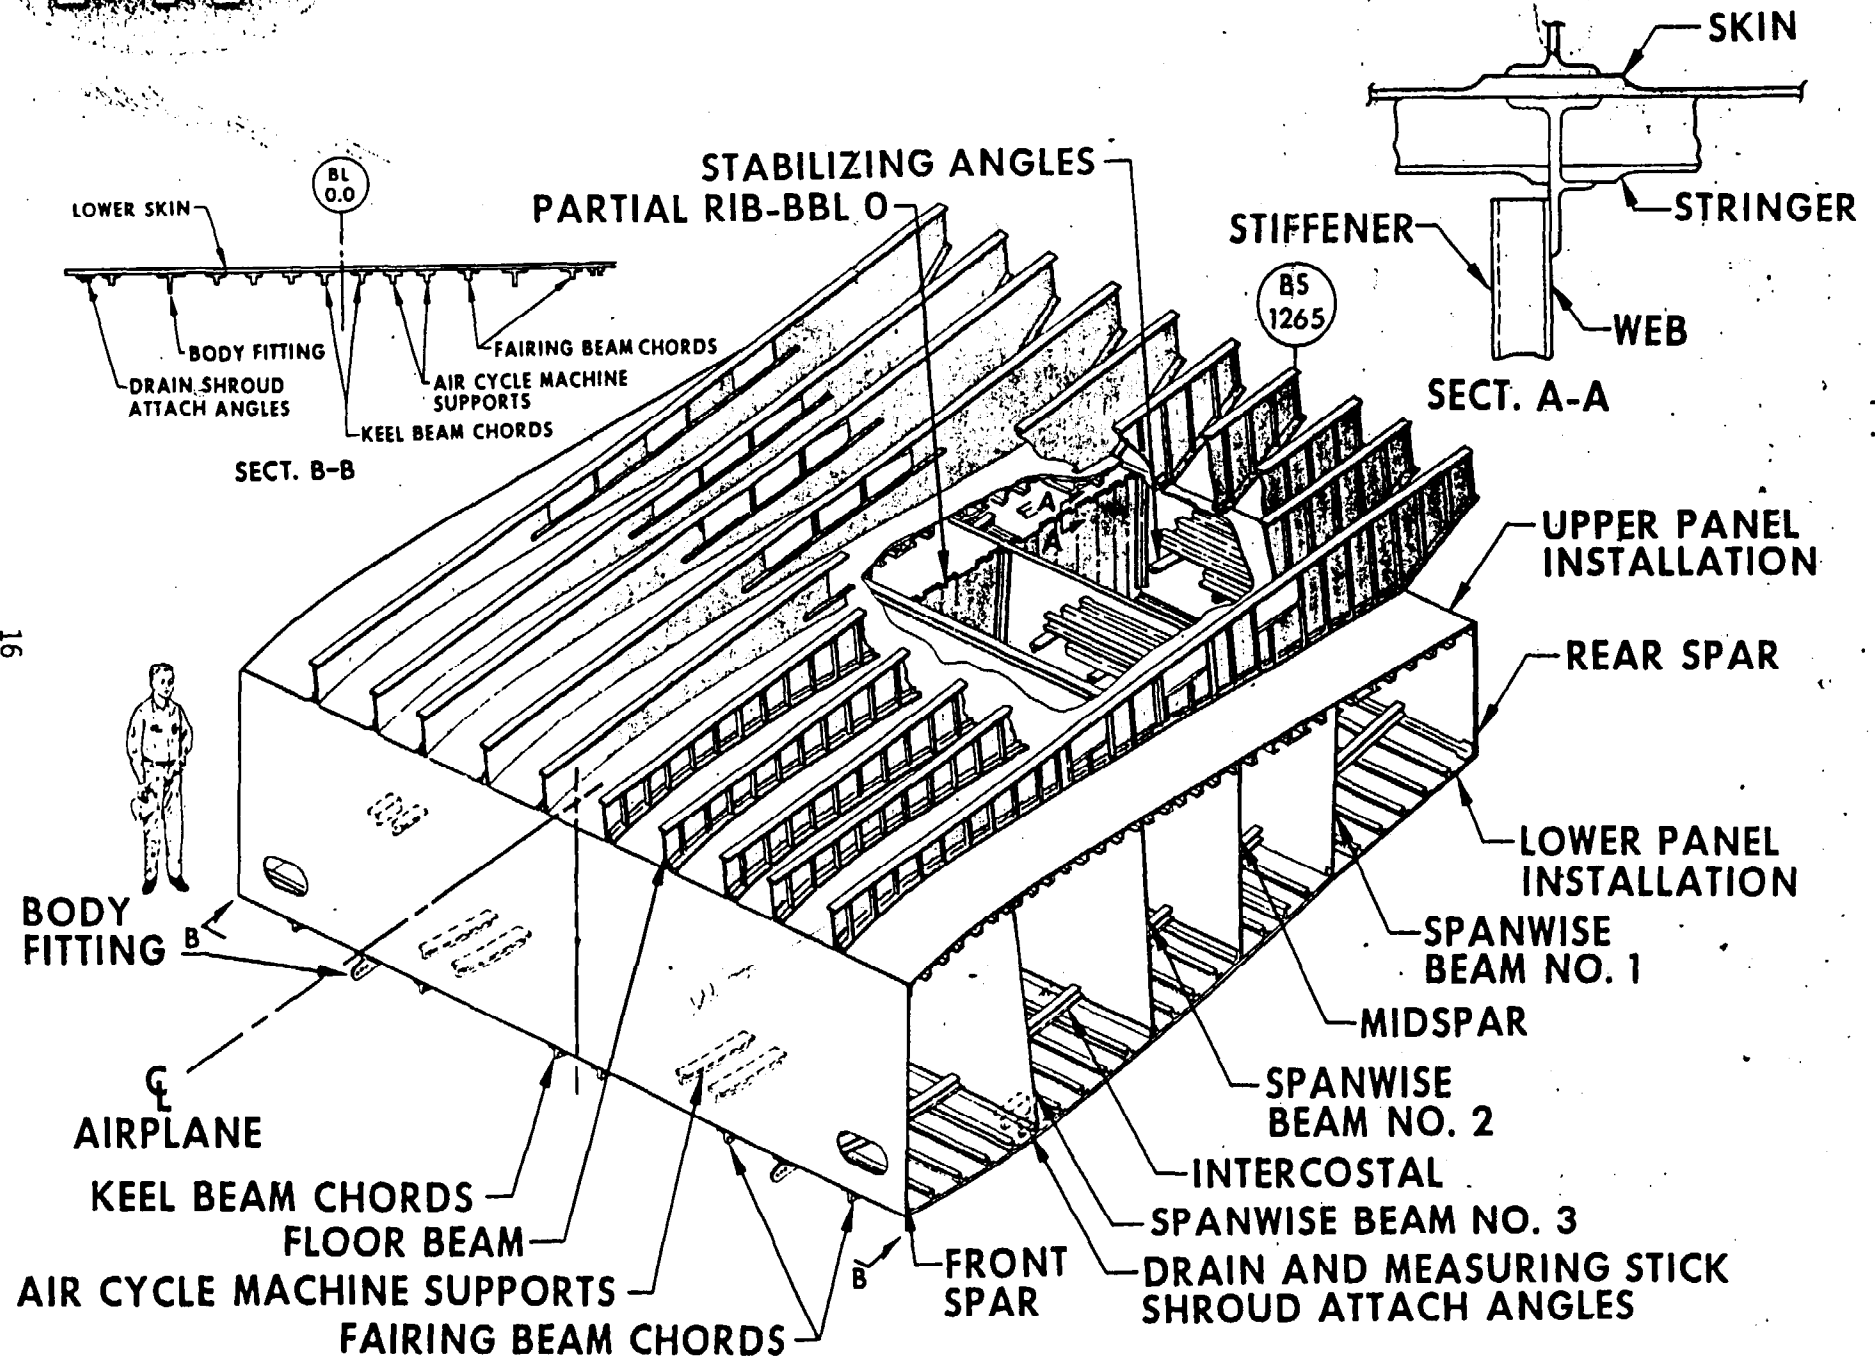
FIGU .2

WING CENTER SECTION

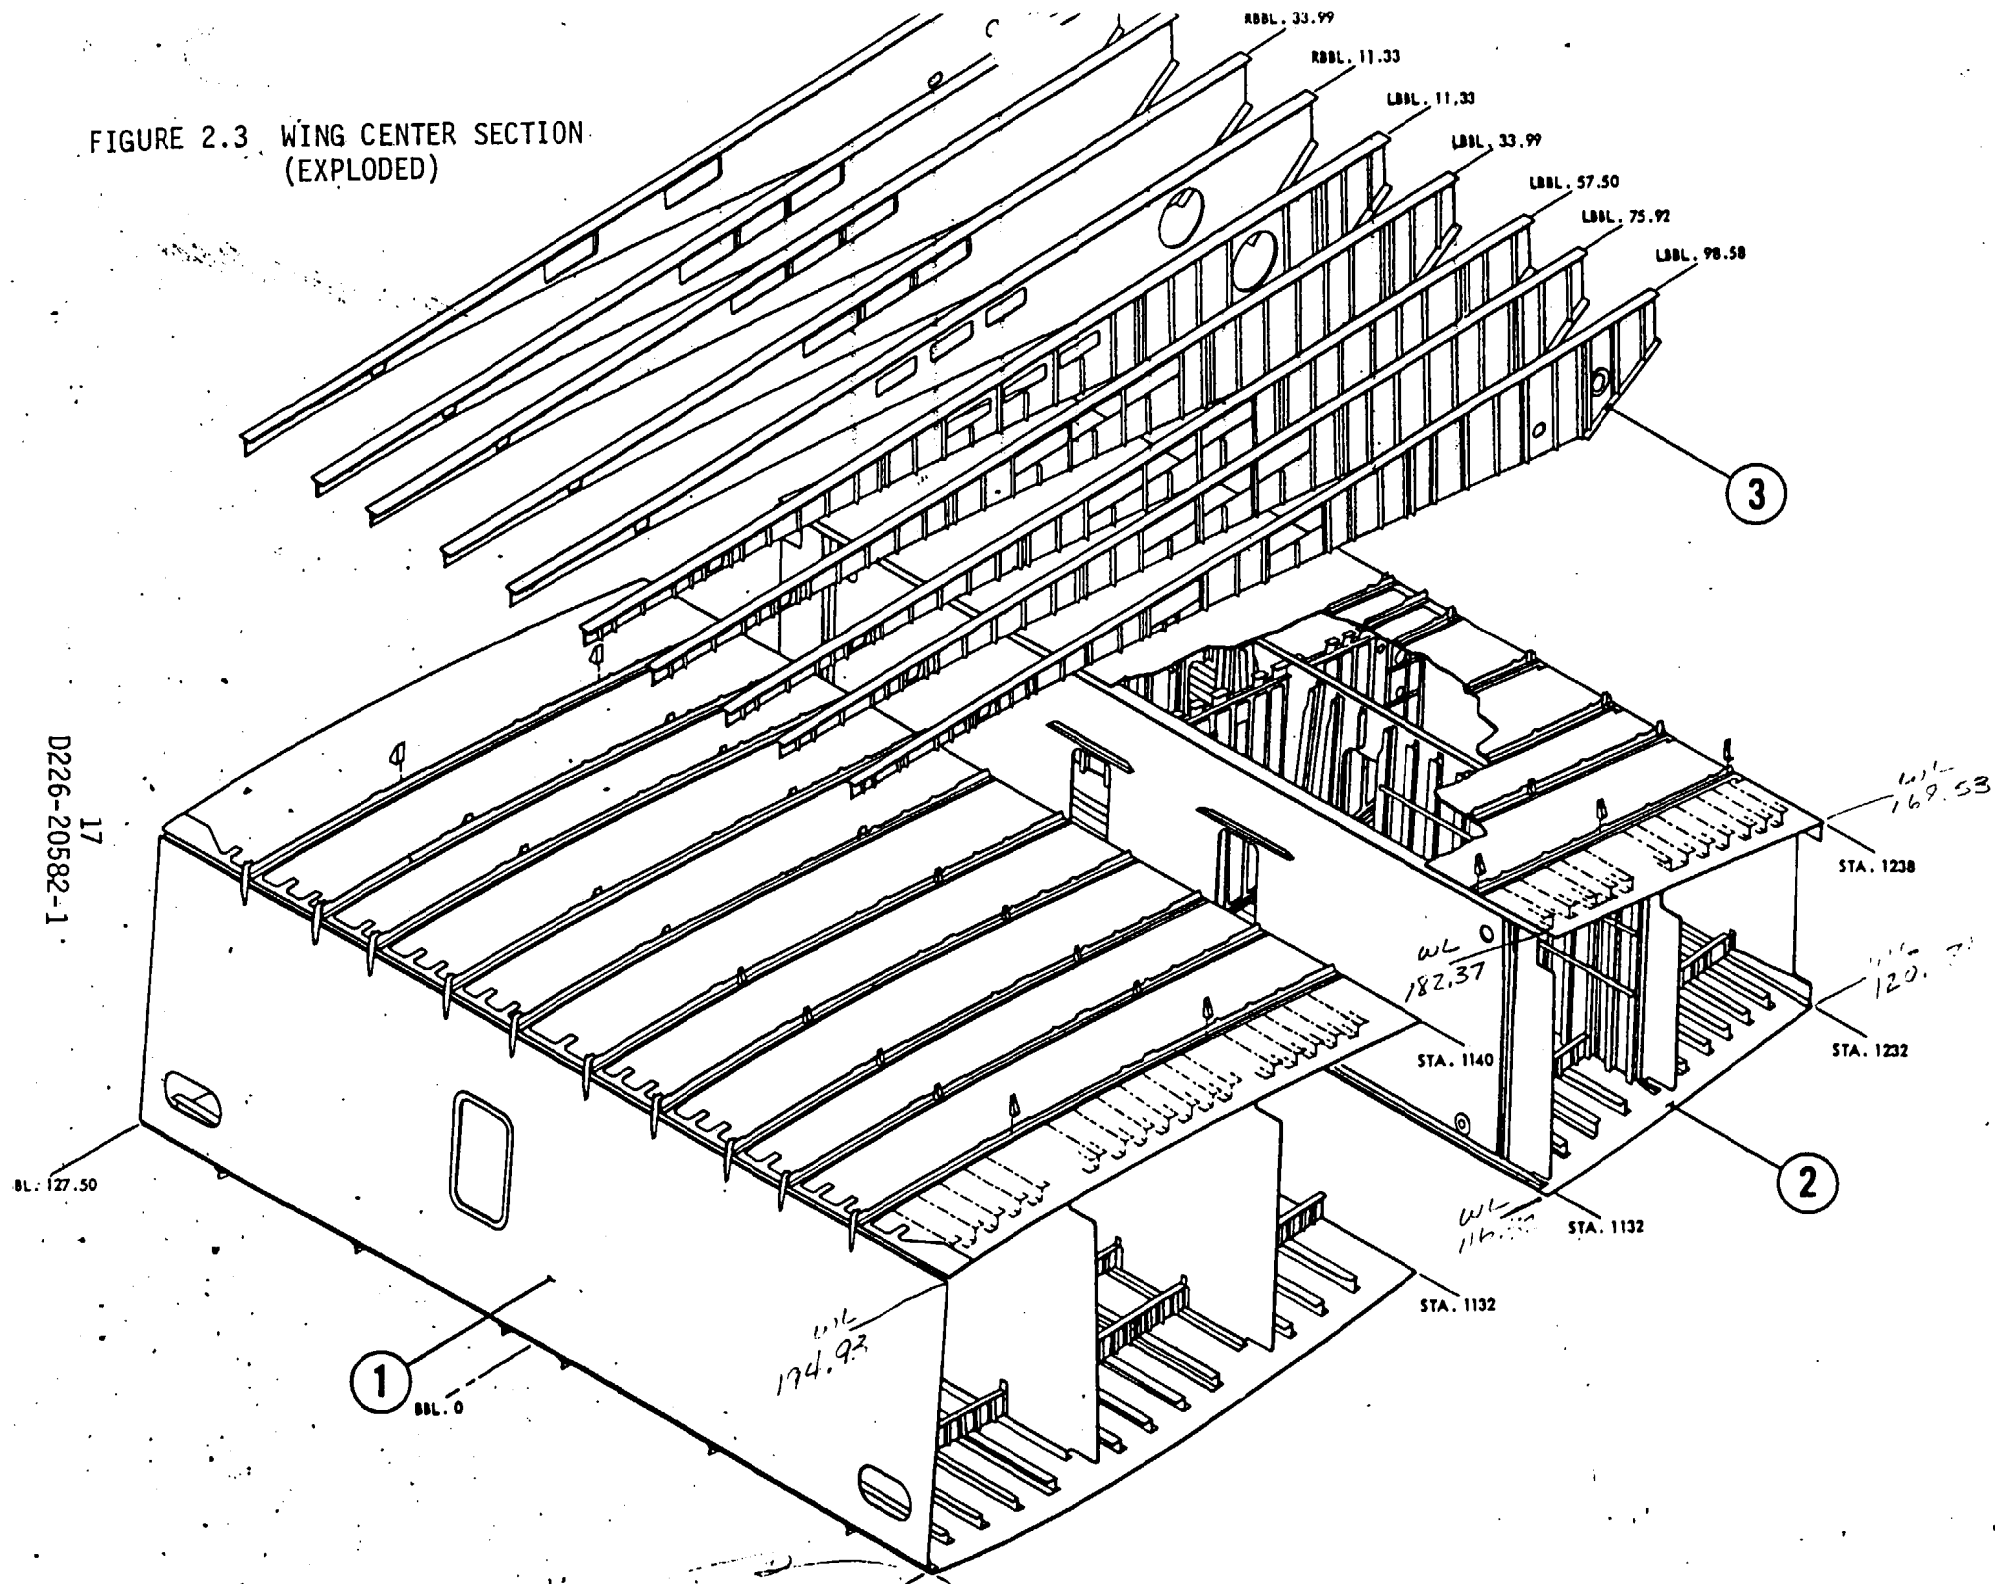
FIGURE 2.3 WING CENTER SECTION
(EXPLODED)

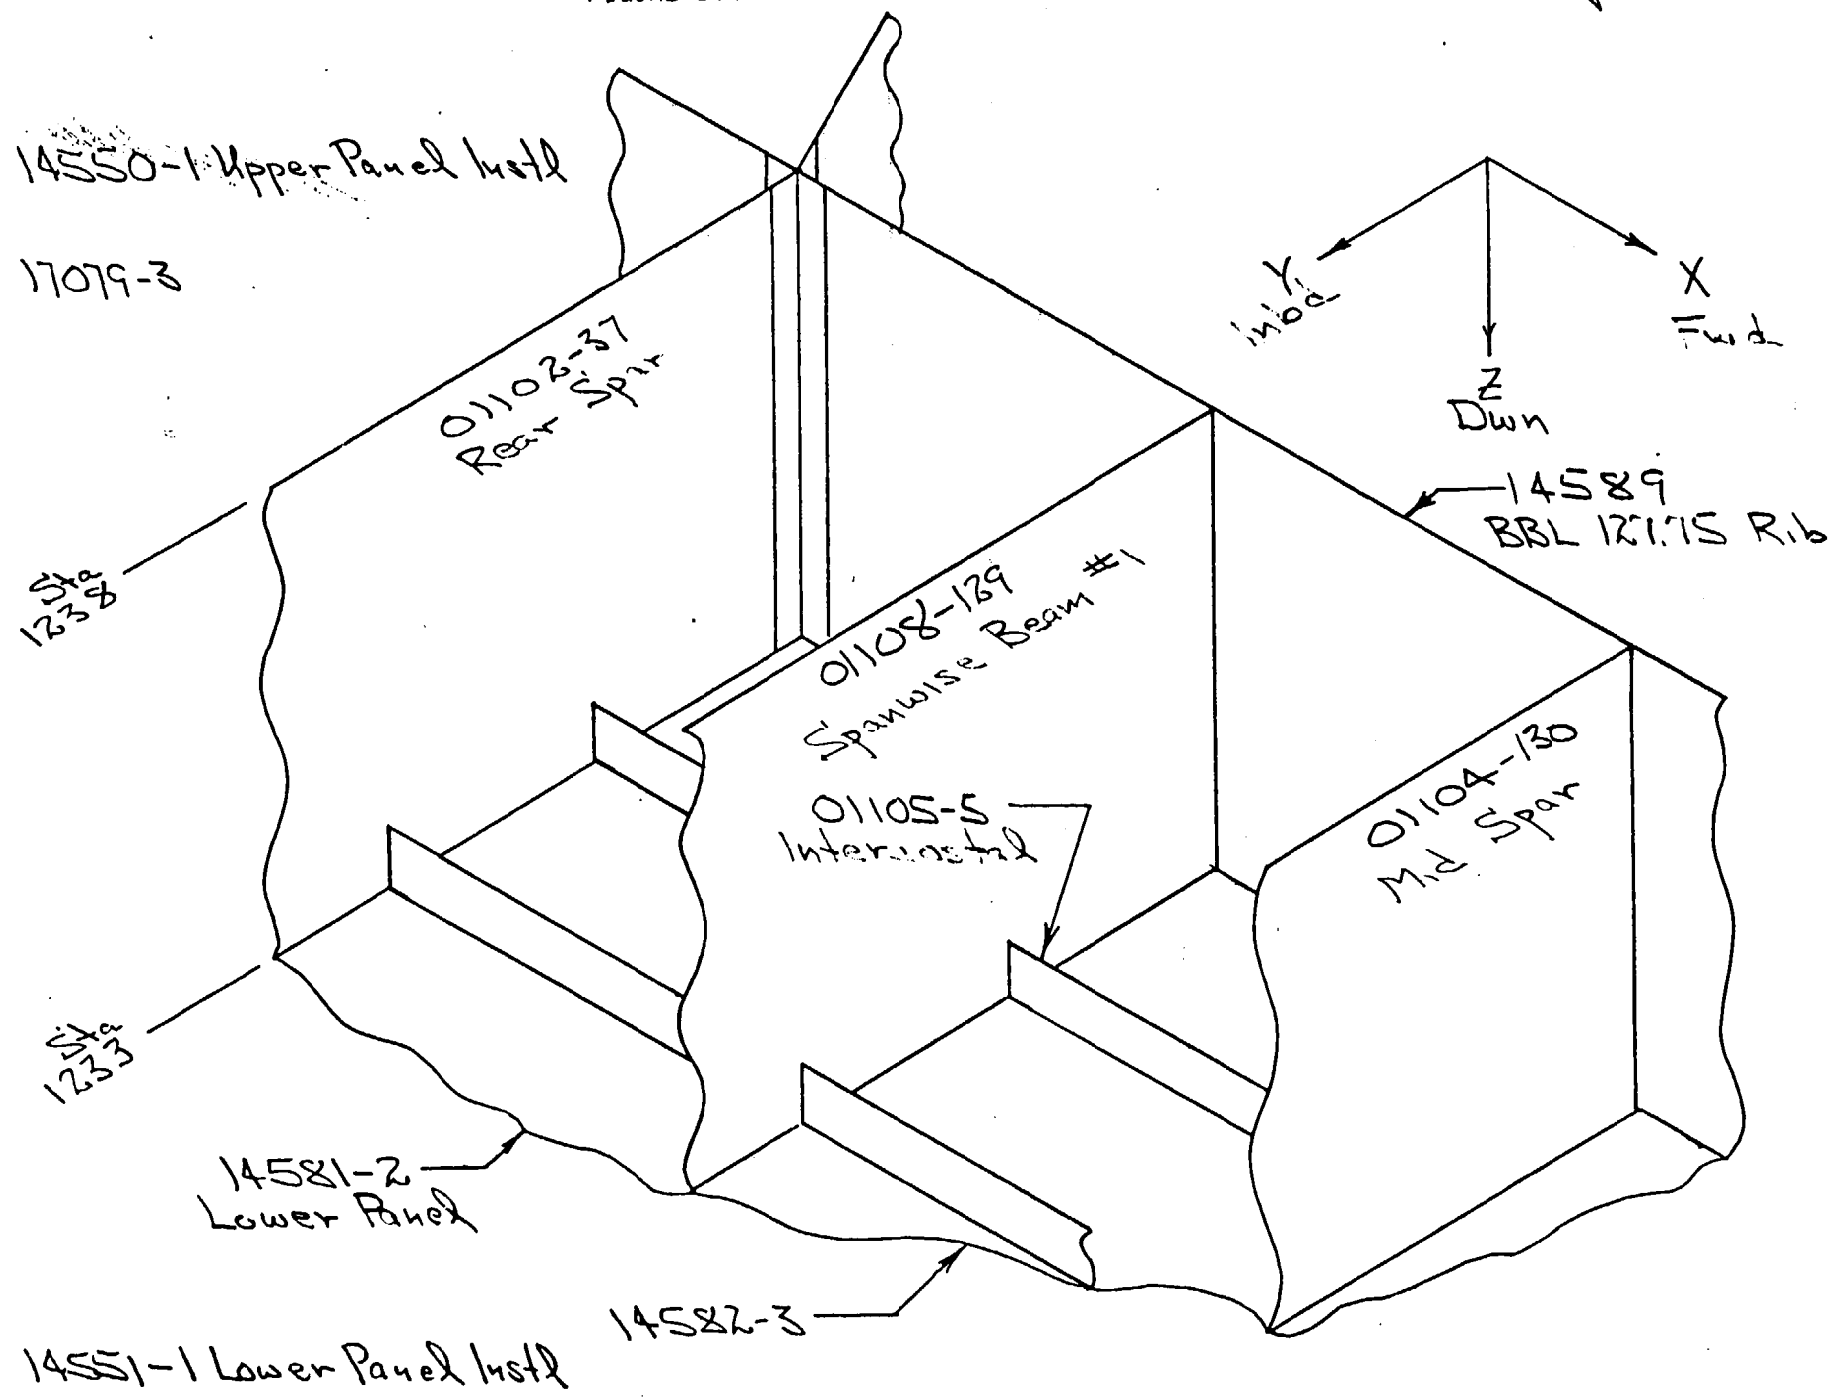
FIGURE 2.4 WING CENTER SECTION (MODELED)

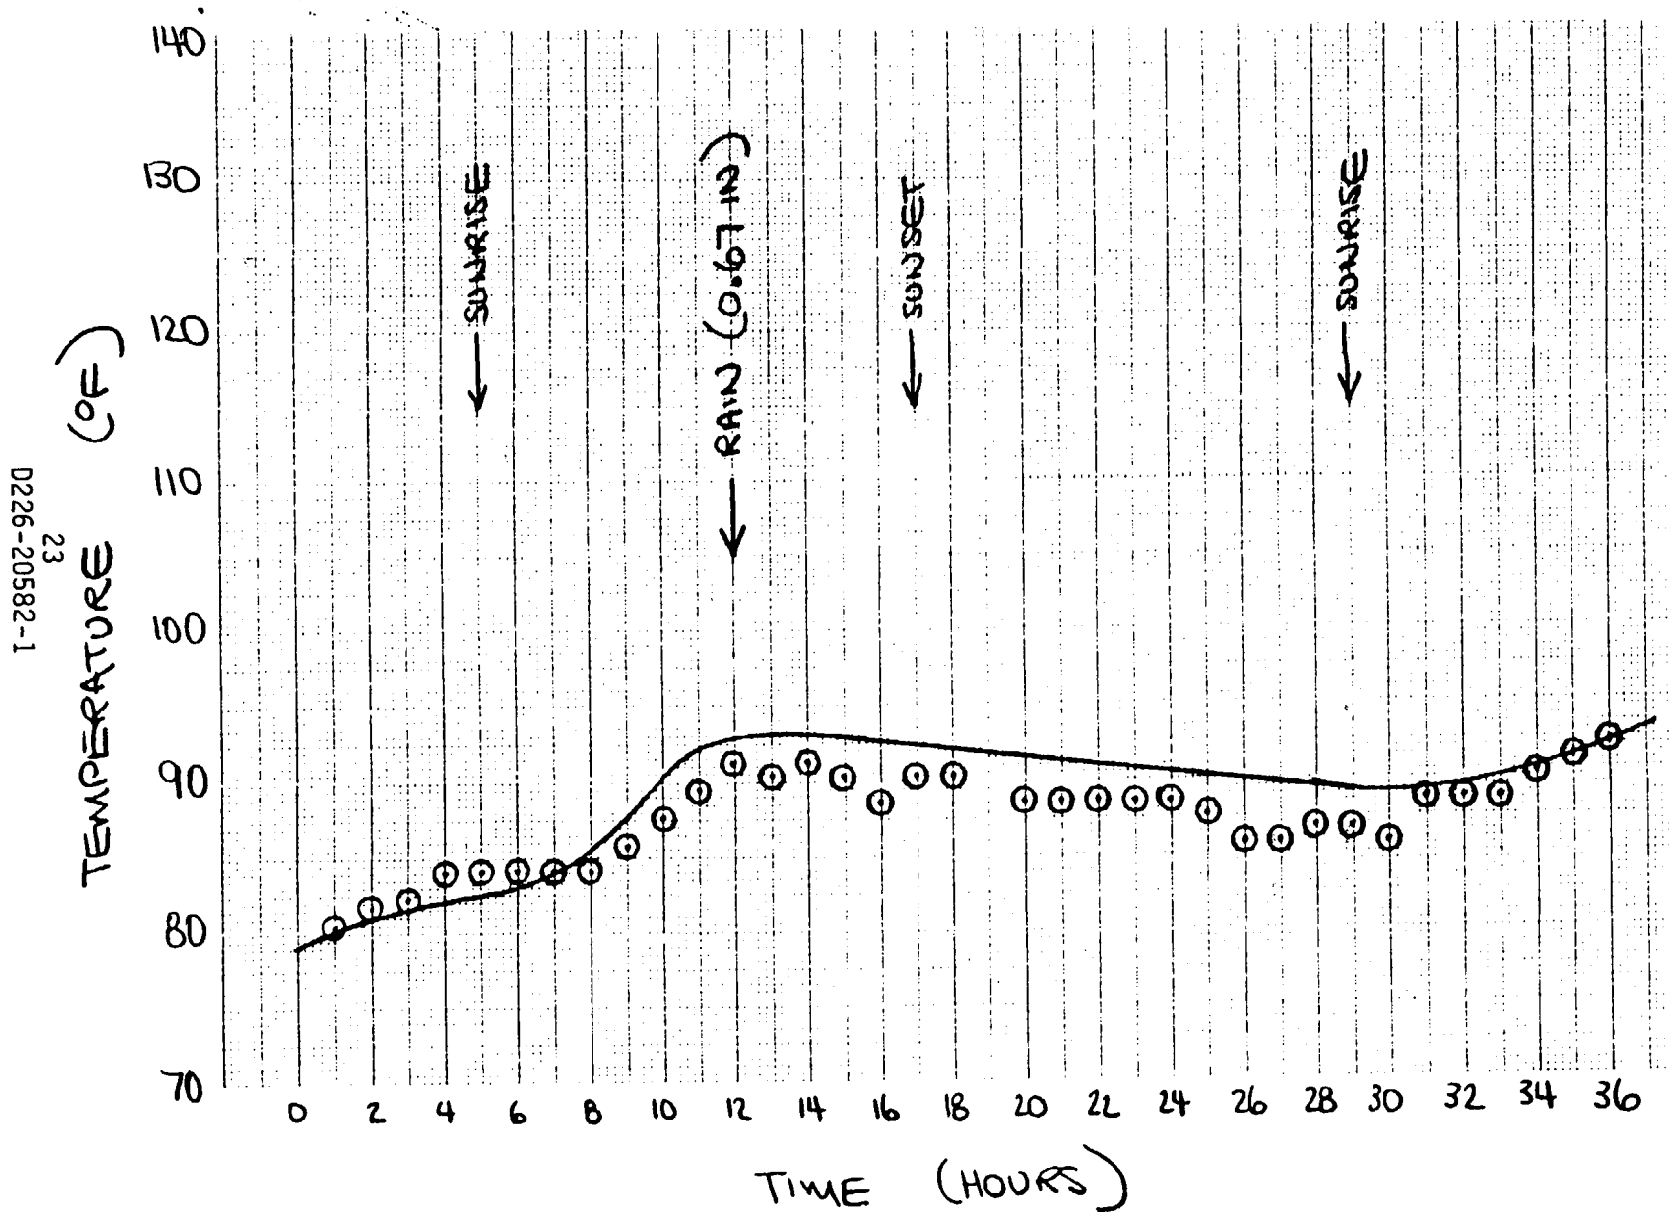
FIGURE 2.6-1 INBOARD MAIN TANK FUEL TEMPERATURE (PANAMA - DECEMBER 1979)

Measurements were made under the fuselage and wing of the aircraft below the center wing tank and the inboard mains. The air temperature under the wing tanks was 24°F above the ambient air temperature. Similarly, the air temperature under the air conditioning equipment bay was 32°F above the ambient air temperature. This increase is due to the pack heat exchanger discharge heat being exhausted in this area and forming a trapped pocket of hot air under the center section of the aircraft.

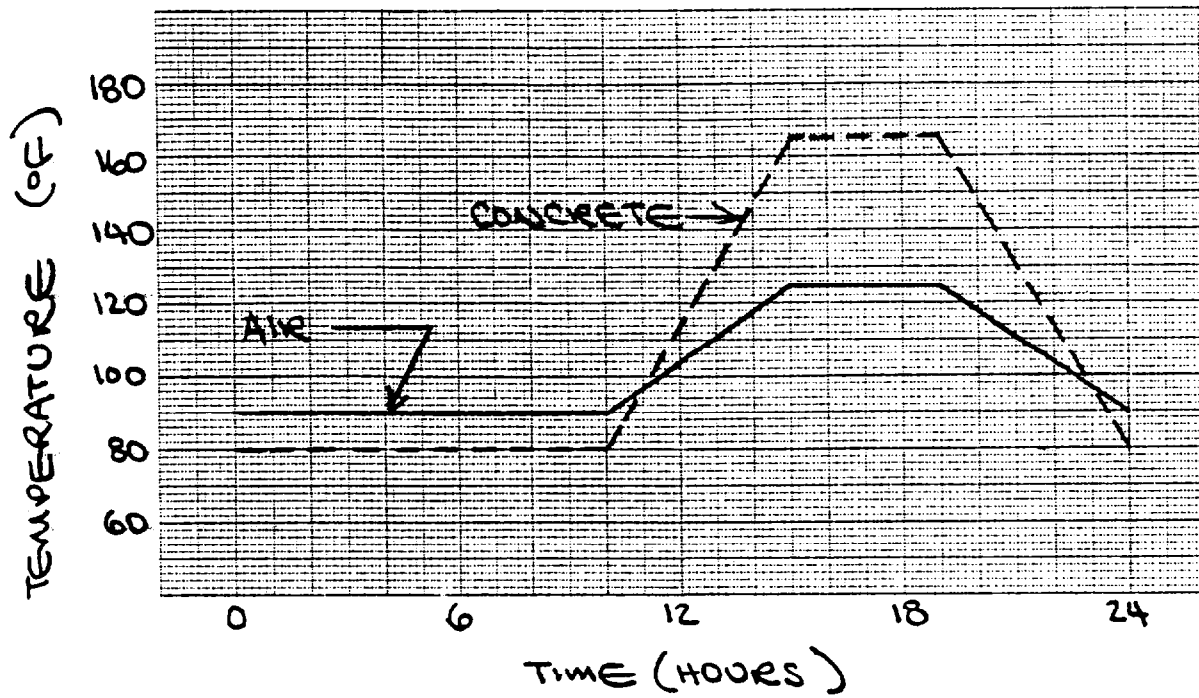
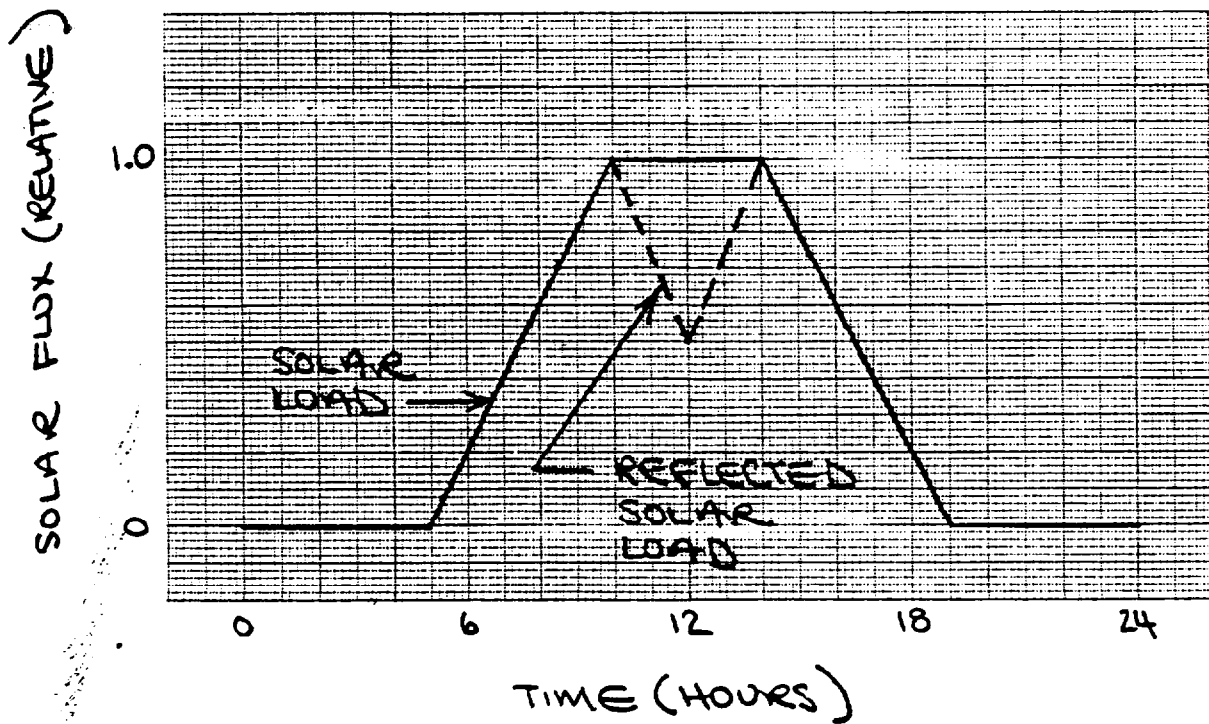
FIGURE 2.7 ENVIRONMENTAL BOUNDARY CONDITIONS

An effective sky temperature of 10°F was assumed for the 85-125°F range of peak day temperatures. An effective sky temperature of 45°F was assumed in the humid environment cases (Panama test simulation).

The solar flux peak value of 105 watts/ft² is taken from MIL-STD-210A. For humid environments (Panama test correlation) a peak value of 90 watts/ft² was used (also taken from MIL-STD-210A).

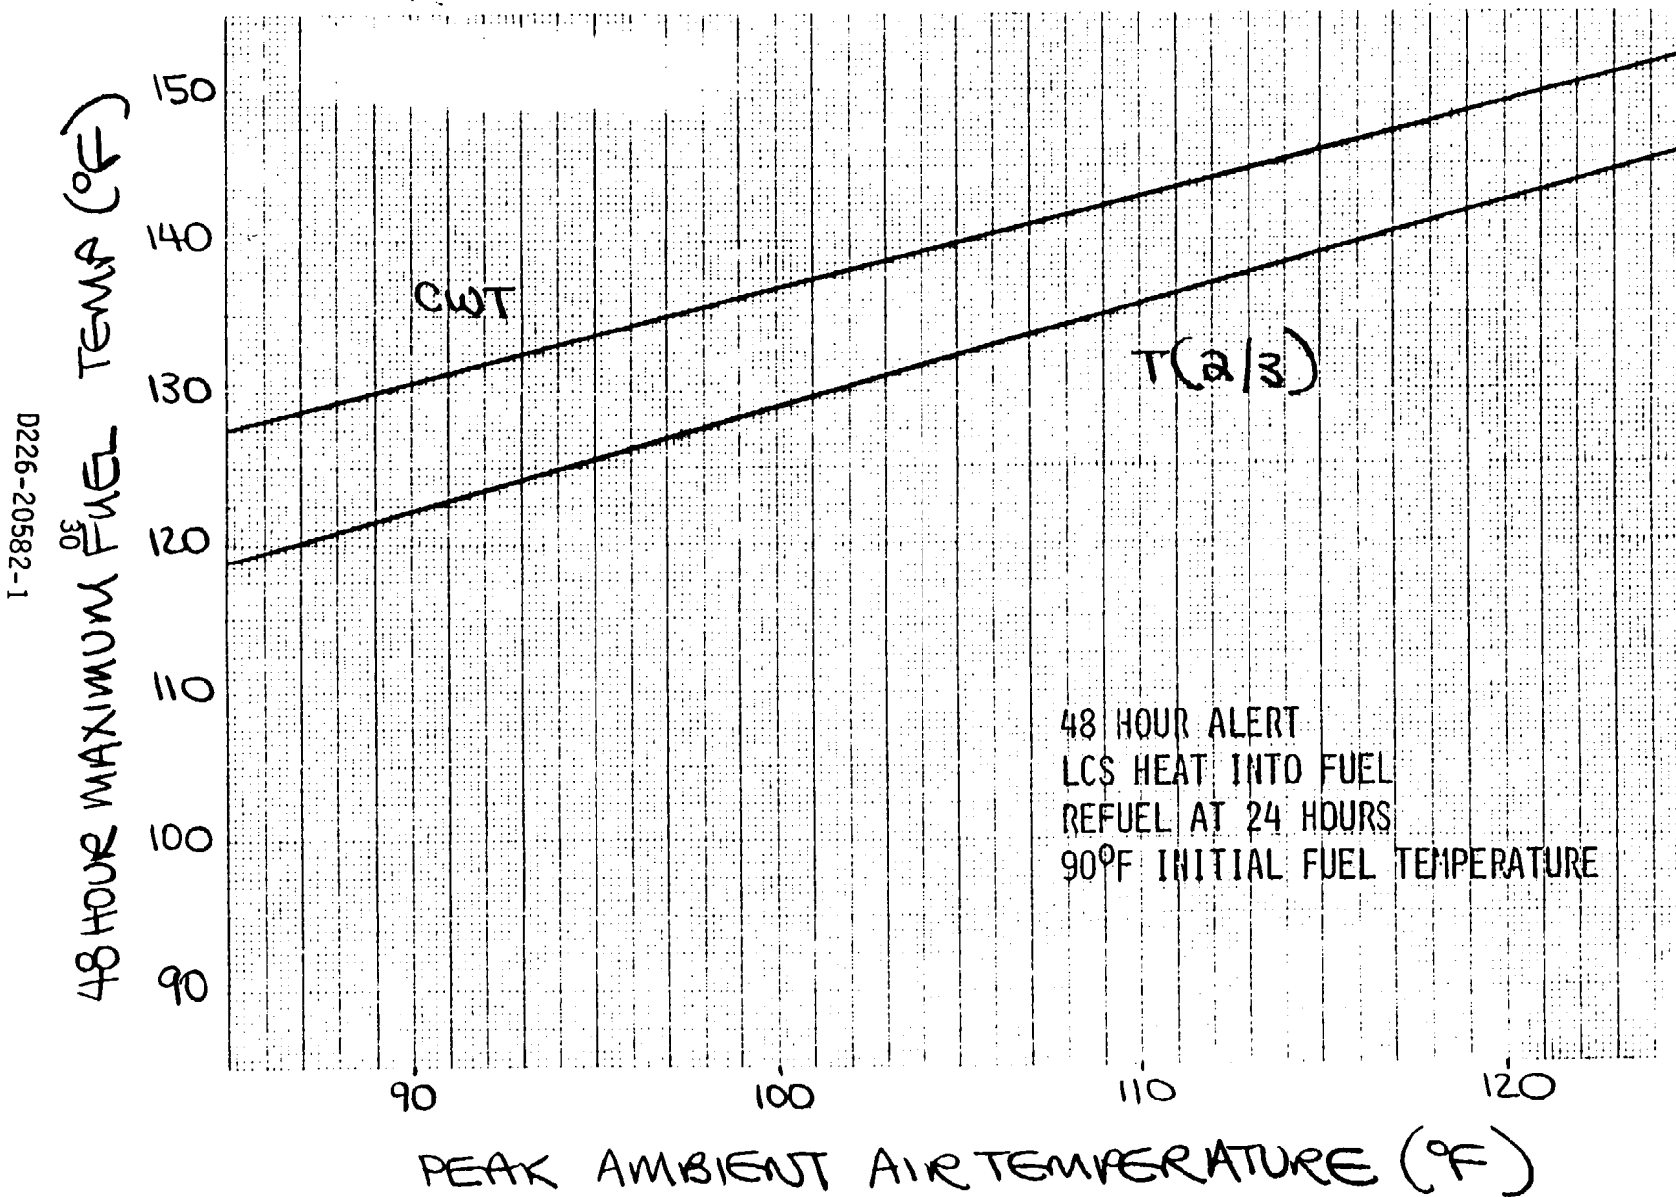
FIGURE 2.8 MAXIMUM FUEL TEMPERATURE WITH AMBIENT ENVIRONMENT VARIATION

However, from Figure 2.8 it can be observed that self-sustained operation above peak ambient air temperatures of 101°F will cause problems with the inboard wing mains.

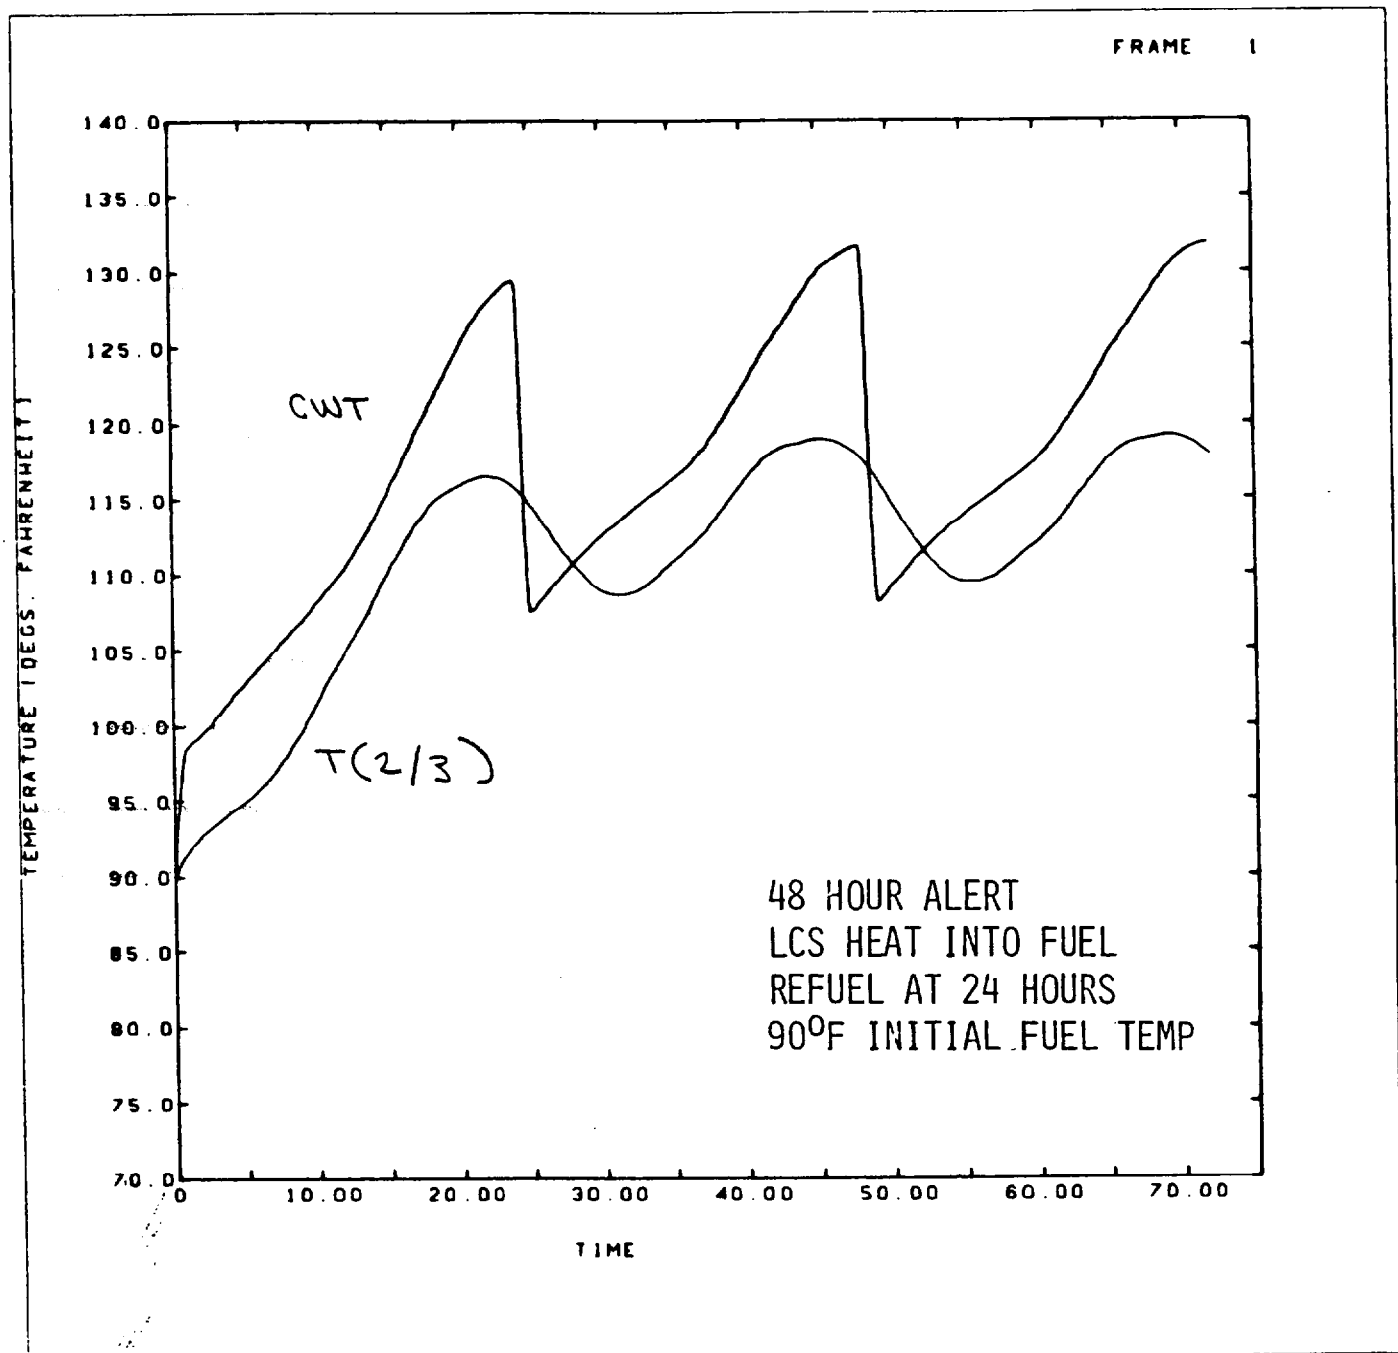
Figure 2.8.1
Fuel Temperature Variation with Time (85°F Peak Air Temperature)

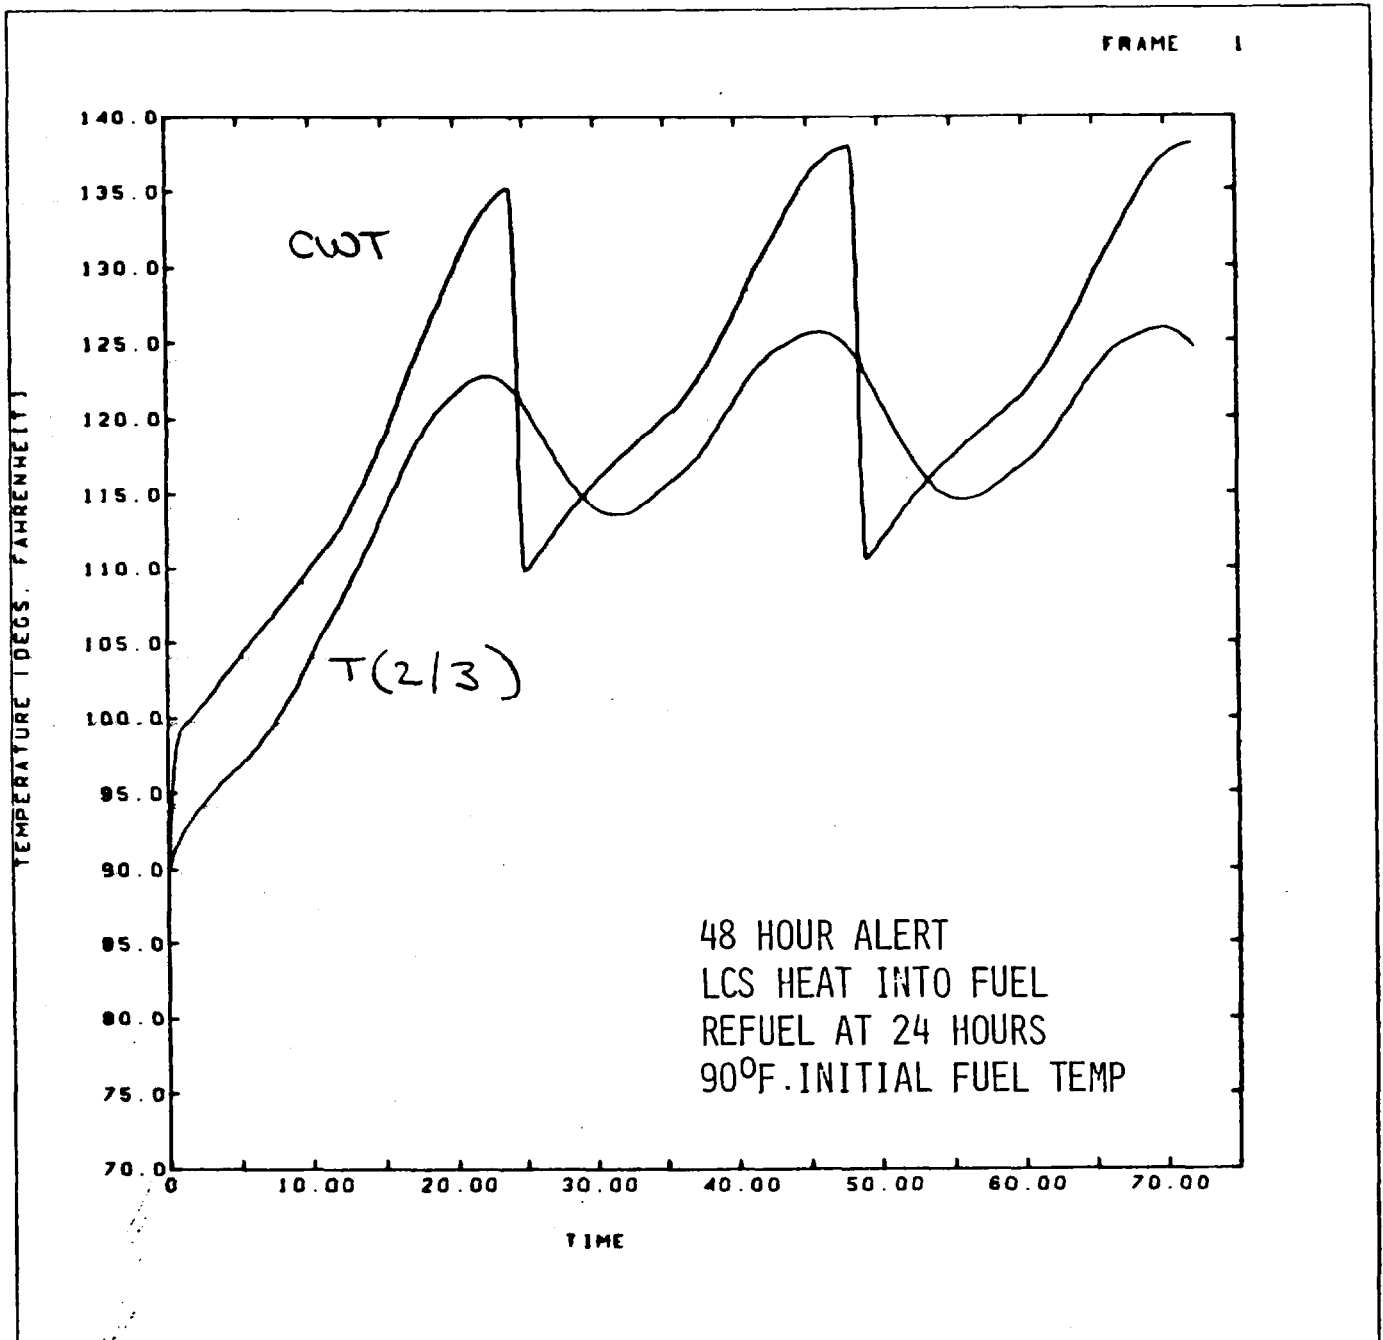
Figure 2.8.2

Fuel Temperature Variation with Time (95°F Peak Air Temperature)

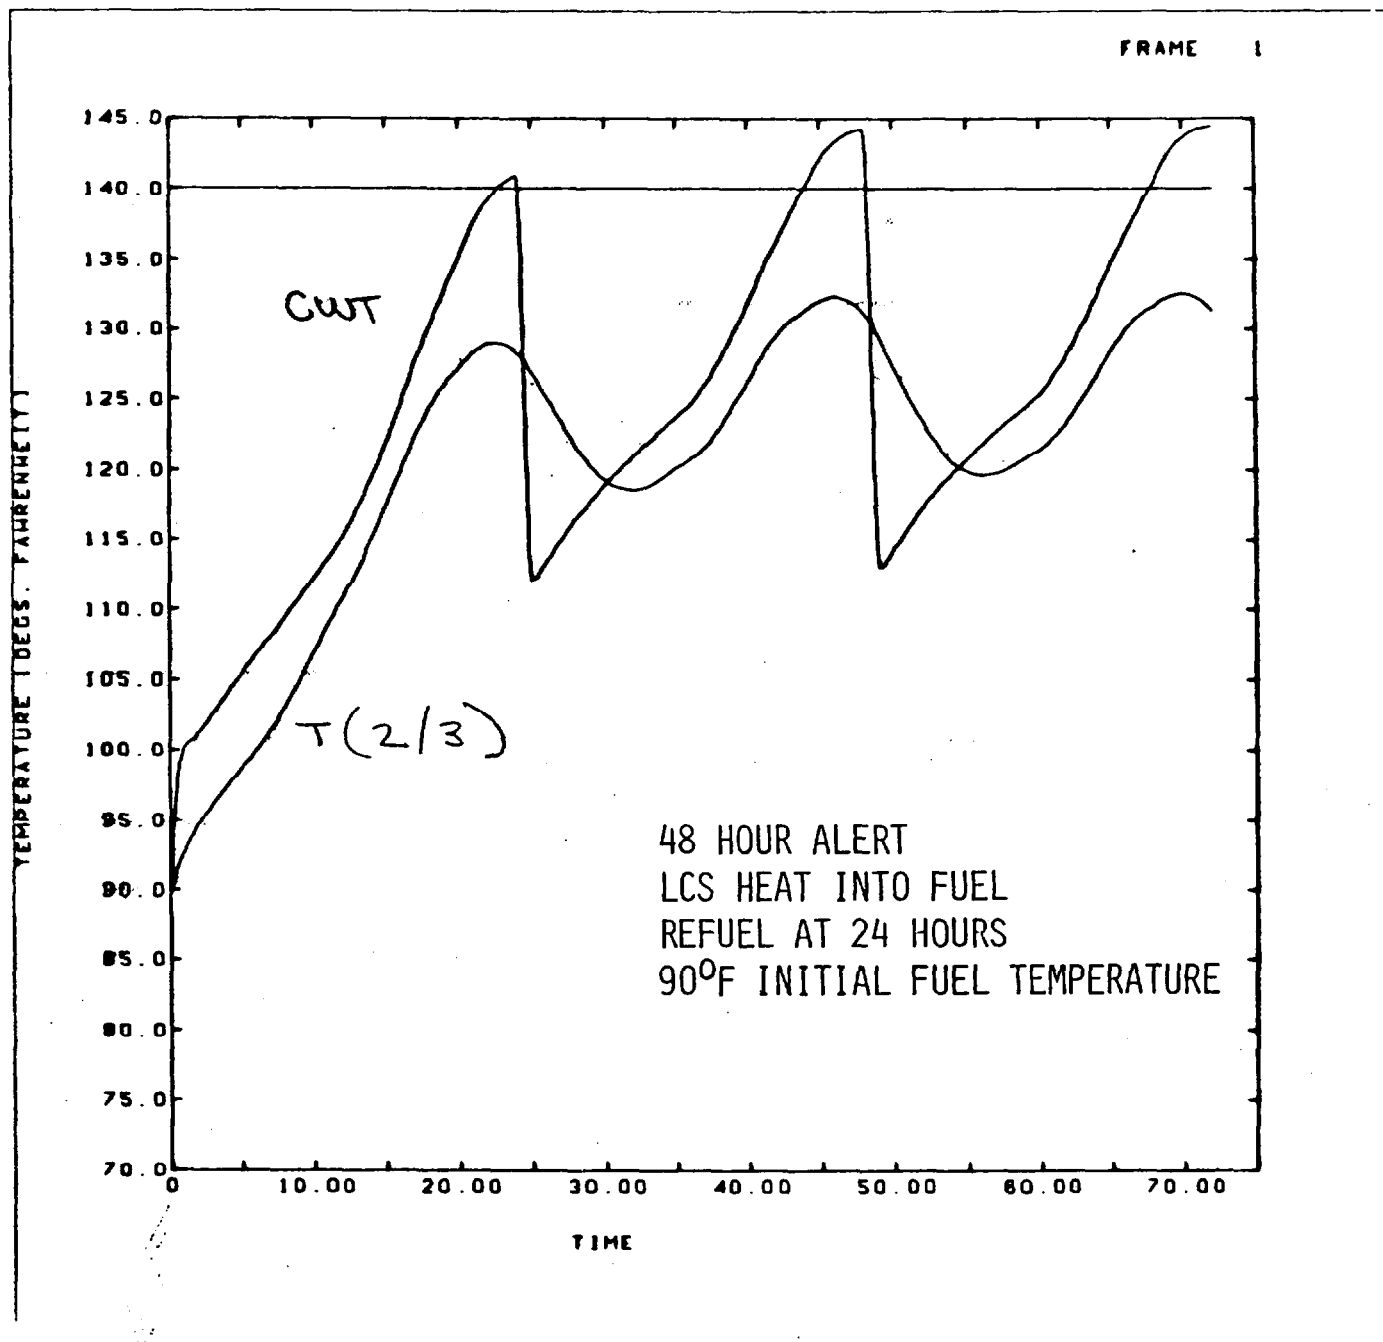
Figure 2.8.3

Fuel Temperature Variation with Time (105°F Peak Air Temperature)
